**ANT NEST CORROSION --
EXPLORING THE LABYRINTH**

Peter Elliott
Corrosion Materials Consultancy, Inc.
P.O. Box 37
Colts Neck, NJ 07722

Richard A. Corbett
Corrosion Testing Laboratories, Inc.
60 Blue Hen Drive
Newark, DE 19713

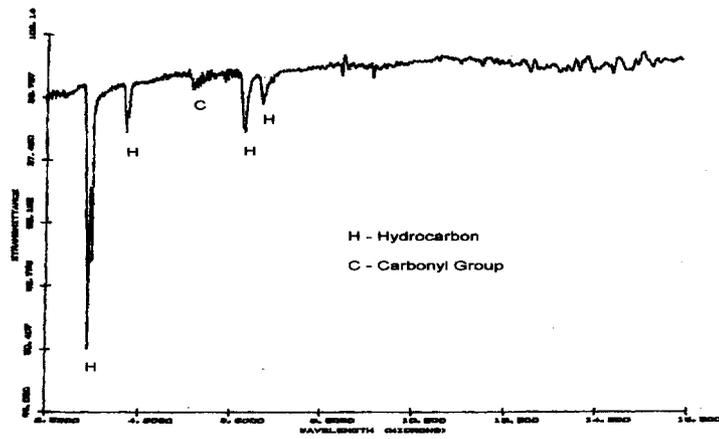
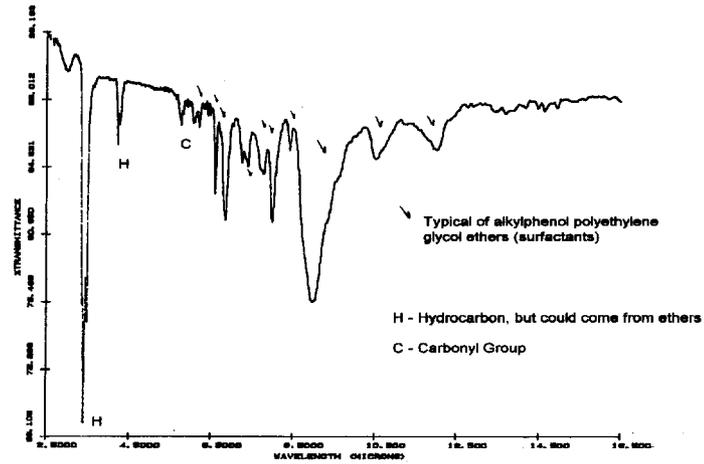
FTIR (Fourier Transformation Infrared) analysis was conducted on wash-down products released from selected tube lengths using an acetone rinse. The FTIR spectra revealed bands due to hydrocarbon materials with a small amount of carbonyl functionality; typical of petroleum-based lubricants. Further spectra revealed alkylphenol-EO adducts (alkylphenol polyethylene glycol ethers) which are non-ionic surfactants, Figure 3. No bands were detected from FTIR Spectra on the as-received tubes.

Figure 3. Infrared (FTIR) spectra of ID products

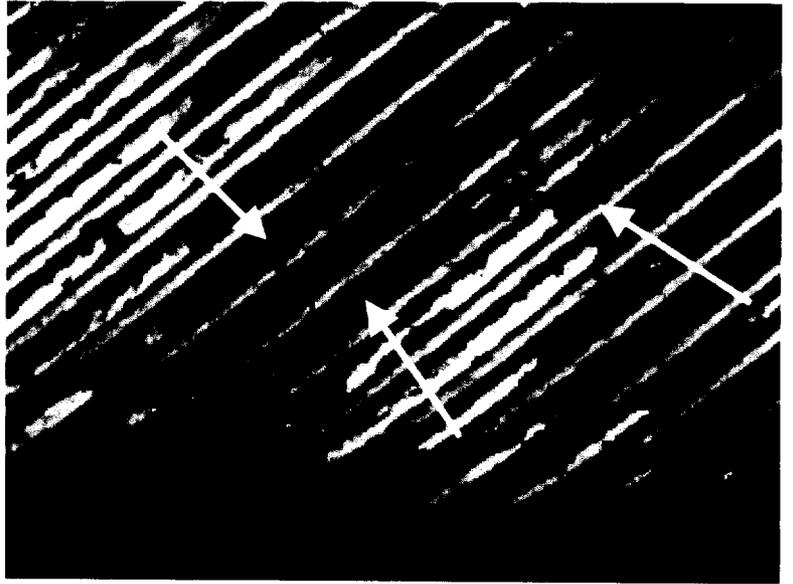
Figure 5. Semi-cleaned condenser tube ID. Arrows indicate areas of black scale and pitting attack. (10X original magnification)

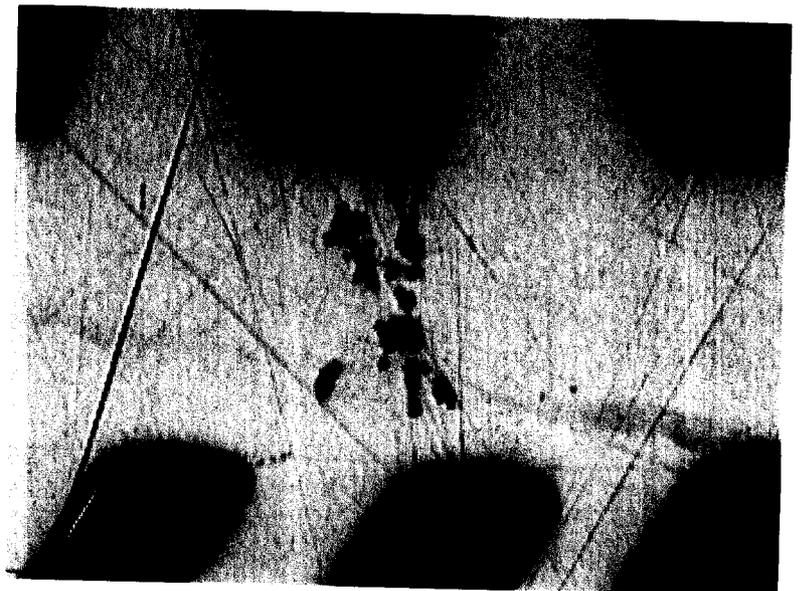
Features. In the as-received condition, the outside diameter (OD) surfaces of the tubes had a reddish-copper color with areas of random black staining. There was no obvious attack, even under microscopic examination. Longitudinal cutting of the tubes revealed the ID surfaces. Under the microscope, small bits of debris and sand particles were observed, and presumed to have come from the cooling tower water. A random black scale, Figure 5, was present which could not be removed by mere scrubbing with a firm toothbrush. Inhibited hydrochloric acid was employed to remove the deposits on the tube, however, the black scale resisted chemical cleaning. At 40X magnification, small pit-like features were observed in the midst of the black scale, Figure 6. Cross-sections revealed extensive ant nest corrosion extending through the tube wall, Figure 7.

Figure 7. Cross-section of evaporator tube (ID is at top). Note the near through-wall penetration of the tunnels. Pit originates on ID surface, top. (60X original magnification)

The tube mill and chiller manufacturer are addressing the issue of lubricants, but as yet no decision has been made to change these fluids. A more intense rinsing program has been initiated, with considerations to use copper inhibitors and hot air drying.
