# Rouging— A Discoloration of Stainless Steel Surfaces

RICHARD A. CORBETT, *Corrosion Testing Laboratories, Inc.*

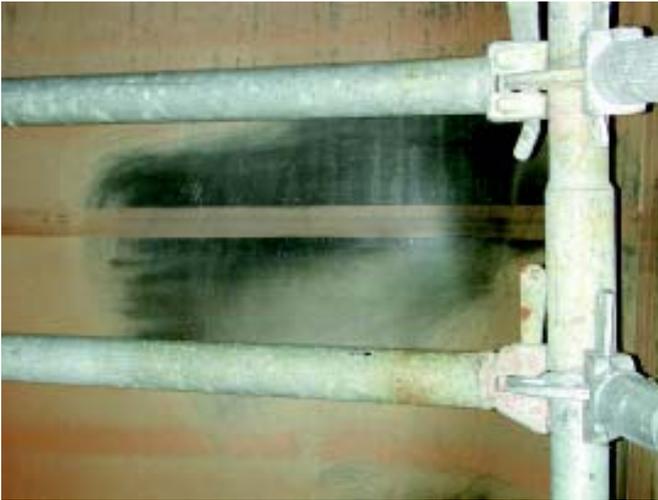
**FIGURE 1**

Rouge wipes easily off the SS substrate but will reform.

**R**ouging is a thin film—usually reddish-brown or gold in color—of iron oxide ( $\text{Fe}_2\text{O}_3$ ) or hydroxide [ $\text{Fe}(\text{OH})_3$ ], typically on stainless steels (SS). The contrast between the film and shiny metal accentuates this aesthetics problem. The rouge film typically wipes off easily with a light cloth (Figure 1), but it reforms while the process fluid is in contact with the SS. This problem is most common in the pharmaceutical industry on the interior surfaces of high-purity water (water for injection) distillation units, storage tanks, distribution systems (piping, valves, pump housings, fittings, etc.), and process vessels.

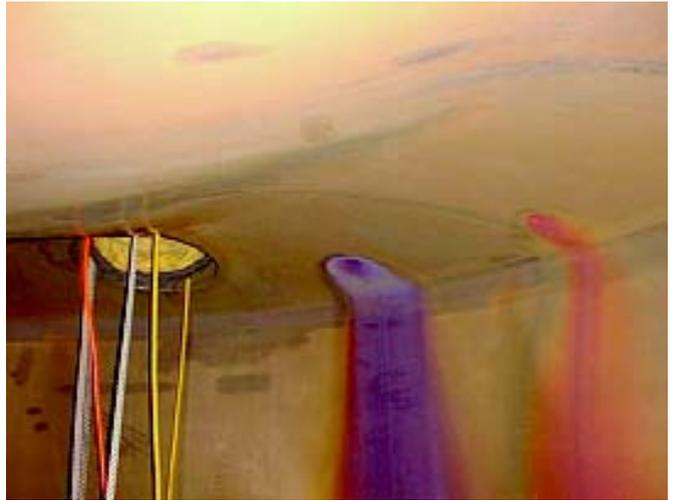
**FIGURE 2**

Rouging comes in many colors and degrees of tenacity.

As stated, rouge is  $\text{Fe}_2\text{O}_3$  (rust), but the film may contain not only iron but also chromium and nickel compounds in various forms, and hence the film may vary in color and tenacity (Figure 2). Rouging occurs more often on type 304/304L SS (UNS S30400/S30403) than on type 316/316L (UNS S31600/

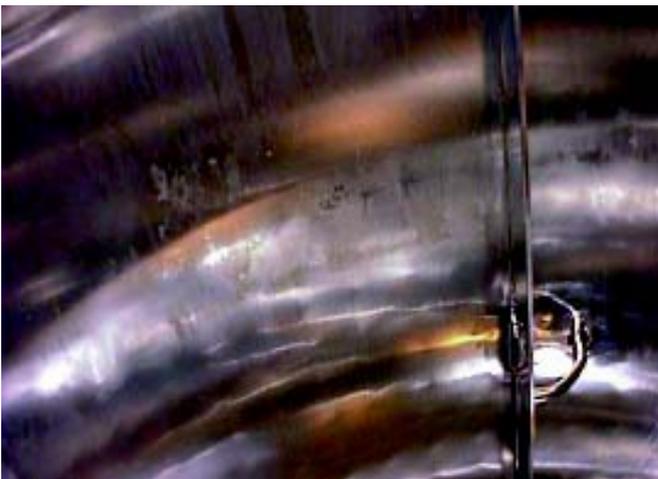
**FIGURE 3**

After repeated cycles, a clean SS surface can take on a multicolored appearance.

tion process is cycled many times, the surface of the SS takes on a light-gold to dark-brown appearance depending on the ionic state of the various oxide layers and their depth (Figure 3).

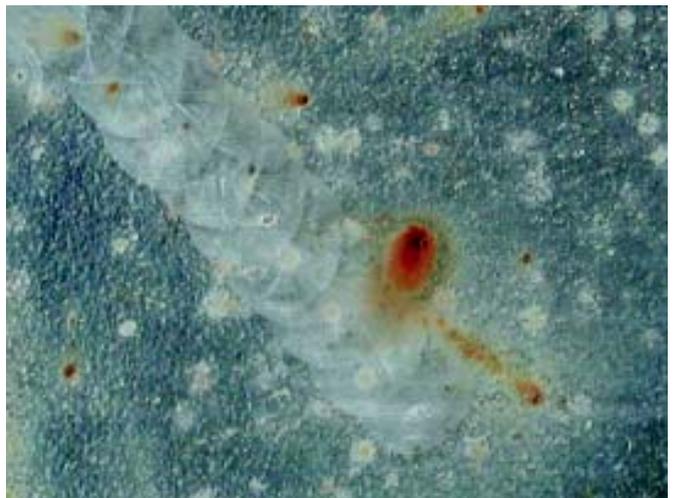
**FIGURE 4**

Rouging or rust blooms identify pit sites.

solution or environment and leave behind a microvoid. This void becomes an occluded cell where solution chemistry can differ from the bulk solution. If the SS does not readily repassivate, then corrosion attack within the void can propagate. The corrosion products within the now-formed pit spill out onto the bulk metal surface, producing localized rouging or rust blooms (Figure 4). After a pit initiates, it may propagate and progress until through-wall penetration occurs. Alternatively, if the pit

heals, the activity ceases and no propagation occurs. However, the red product remains to indicate that something has occurred.
